Scan report date
31/08/2024 12:28

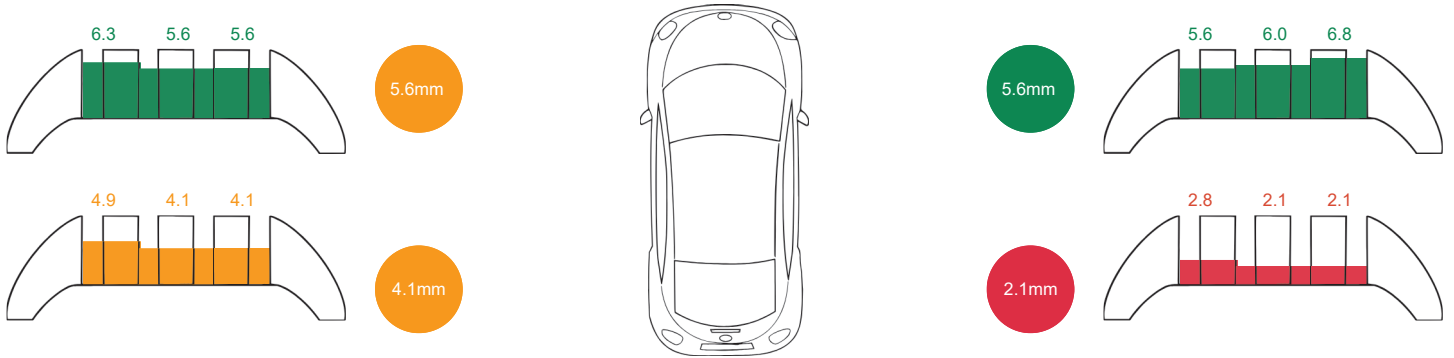
- Uneven profile on the front left tyre. Please check wheel alignment.
- Rear left tyre is approaching the recommended wear limit of 3.0mm (4.1mm)
- Uneven profile on the rear left tyre. Please check wheel alignment.
- Replace the rear right tyre (2.1mm)
- Uneven profile on the rear right tyre. Please check wheel alignment.

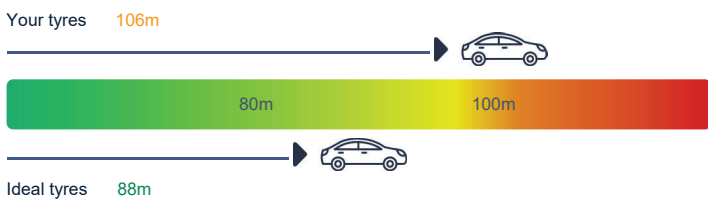
Stopping distance

Based on most worn tyre fitted to all positions, when travelling in wet conditions at 50mph:
